**SARWARAN PRIMARY SCHOOL**  
UNDER THE COMMANDER'S EMERGENCY RESPONSE PROGRAM  
**ERBIL, IRAQ**

**SIGIR PA-08-120**  
**APRIL 21, 2008**

SUBJECT: Report on Project Assessment of the Sarwaran Primary School, Erbil, Iraq (Report Number SIGIR PA-08-120)

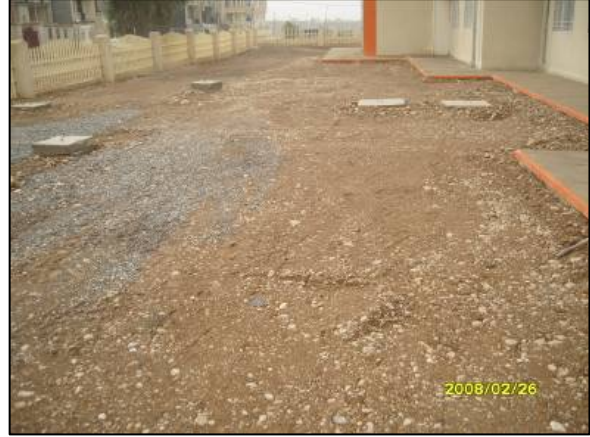
Site Photo 2. Correction of grading and grading level subsequent to site visit (Photo courtesy MND-NE).

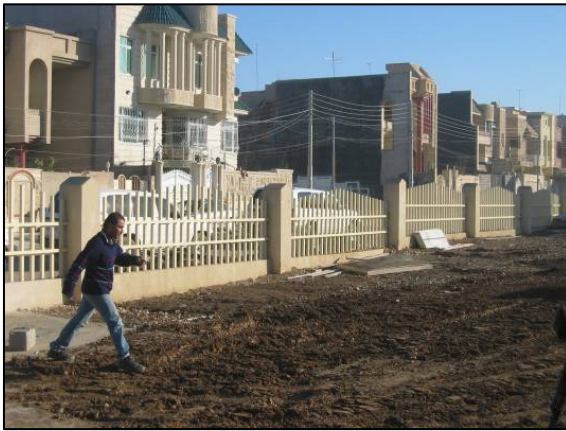
The perimeter fence is made from a concrete block foundation and has pillars spaced approximately five meters apart and filled with vertical steel pipe fencing. The outside of the two-story building was being finished at the time of the visit. The entrance doors were made of tempered glass and were installed properly. Materials and workmanship for these items were adequate. Site Photos 3 through 5 show the perimeter fence, external finishing, and glass doors.

Site Photo 3. Perimeter fence

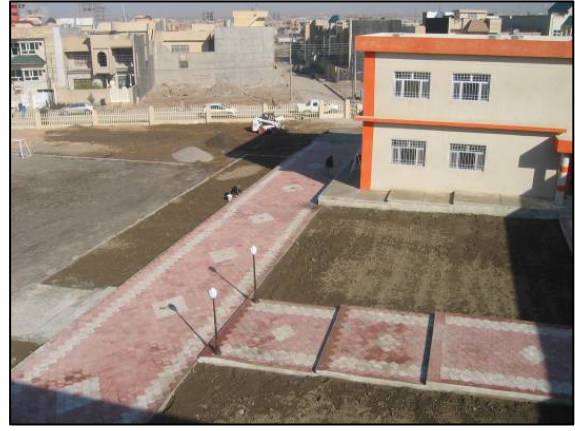
Site Photo 4. Outside building finish

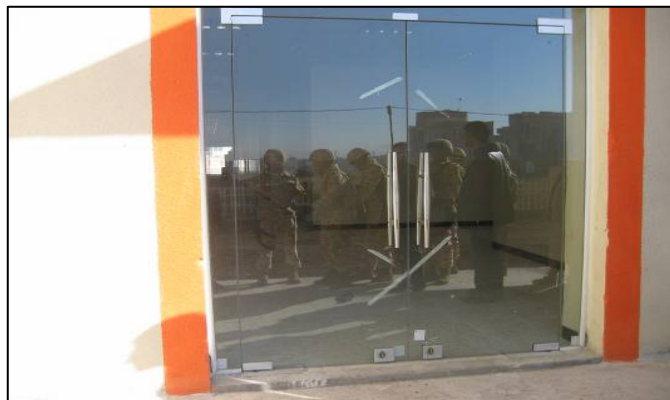
Site Photo 5. Tempered glass entry door

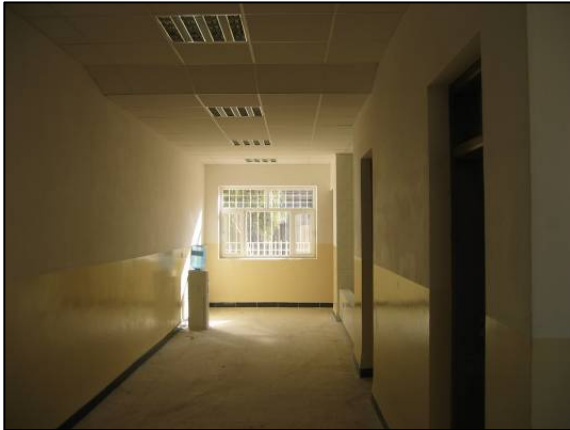
The hallways and classrooms were completed with tiled floors, plaster walls, and incandescent lighting. Two split air conditioning/heating units were installed in each room. We tested a sample unit and it functioned properly. Site Photos 6 and 7 show the hallway and a split air conditioning unit.

Site Photo 6. Hallway on bottom floor

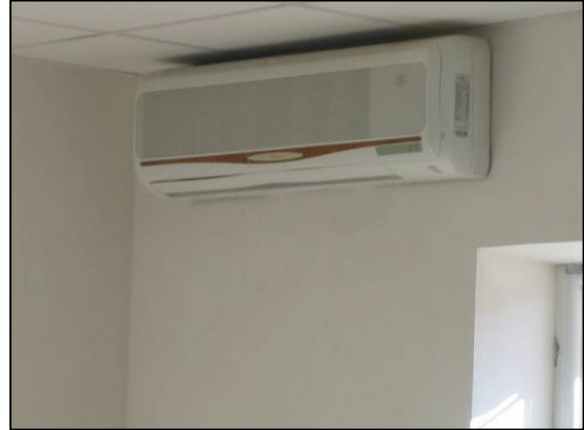
Site Photo 7. Split air conditioning unit

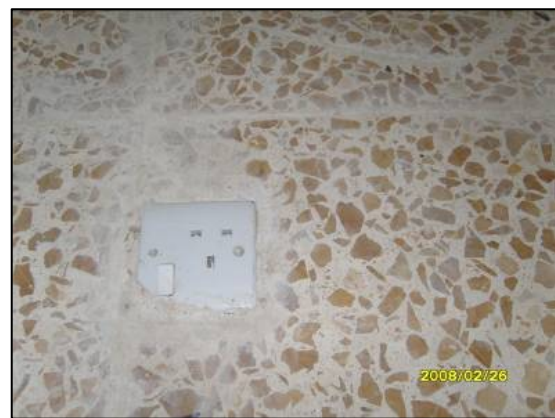
Site Photo 9. Corrective actions subsequent to site visit to recess and cover receptacle. Portion of receptacle obscured. (Photo courtesy of MND-NE).

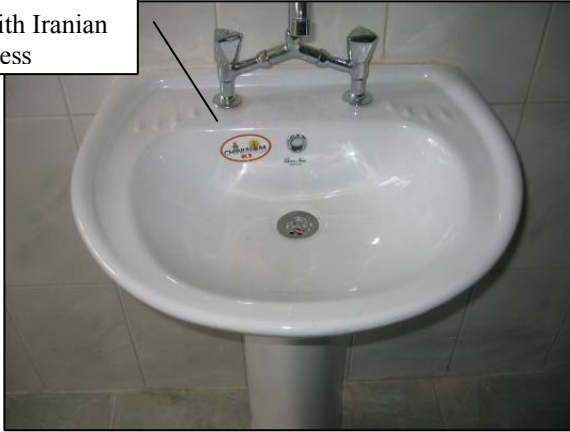
Each of the four bathrooms contained three eastern toilets, one western toilet, and three sinks. The quality and workmanship appeared adequate. The contract required the wash basins and water closet fixtures be Iranian-made products. Although we could not conclusively verify that the products were made in Iran,

we noted that a web site for the sink brand ([www.chininam.ir](http://www.chininam.ir)) was an Iranian site. Site Photos 10 through 13 show the bathroom fixtures and ceiling.

Sink label with Iranian website address

Site Photo 10. Bathroom sink

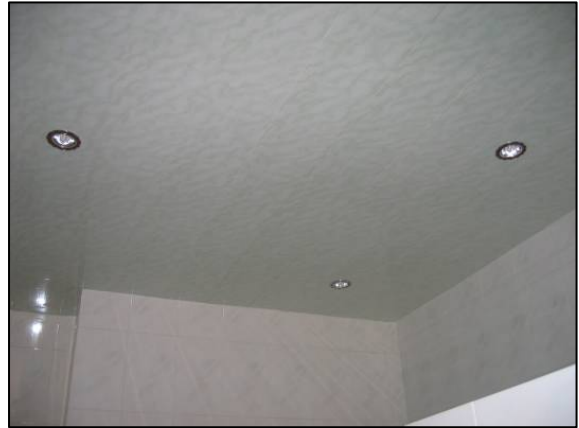
Site Photo 11. Bathroom ceiling

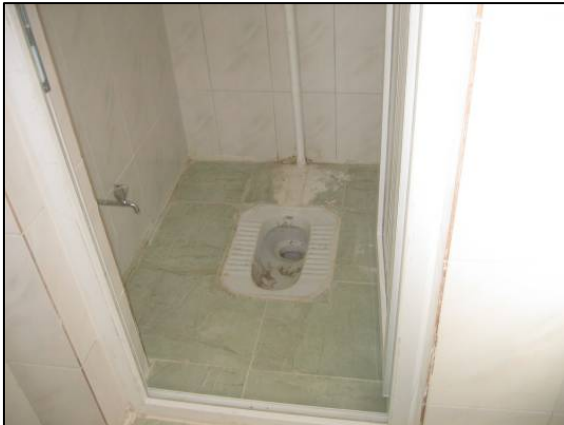
Site Photo 12. Eastern toilet

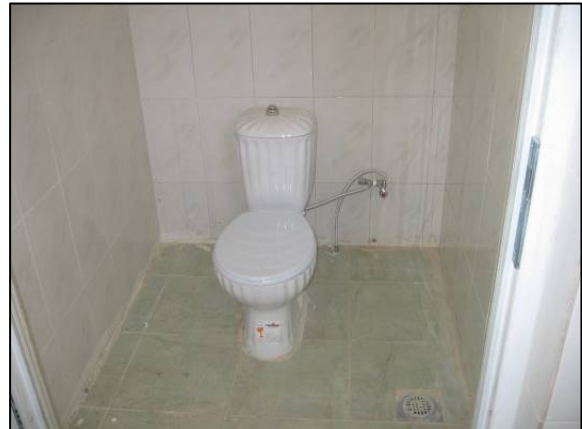
Site Photo 13. Western toilet

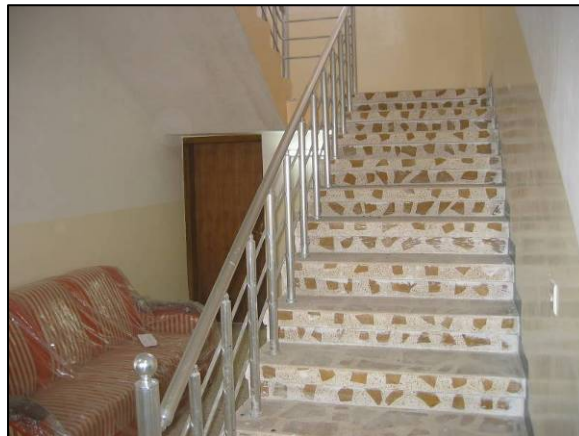
Windows were installed and functioned properly. Tiled stairways were guarded with stainless-steel railings that were adequately secured. The slope and step dimensions were adequate. Classroom title signs were installed on the outside of each classroom. Site Photo 14 shows the stairway and railing.

Site Photo 14. Stairway and railing

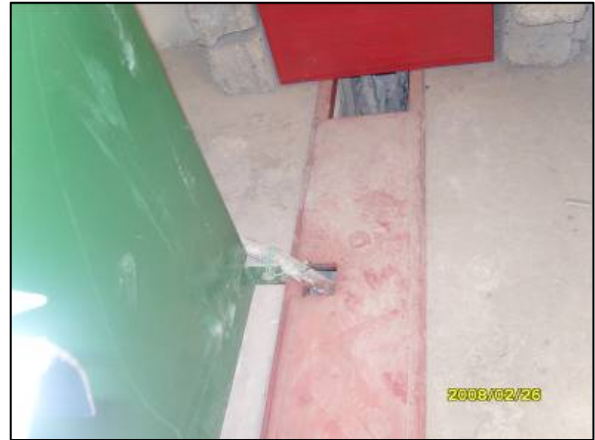
Site Photo 16. Corrective action subsequent to site visit to install automatic turnover box and properly connect to the main line. (Photo courtesy of MND-NE).

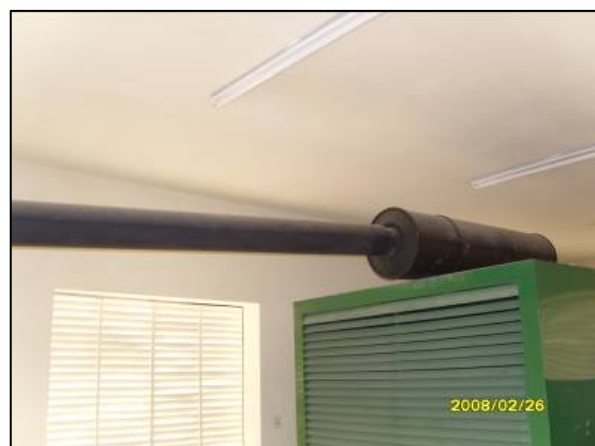
Site Photo 18. Corrective action subsequent to site visit to vent the exhaust out of the building. (Photo courtesy of MND-NE).

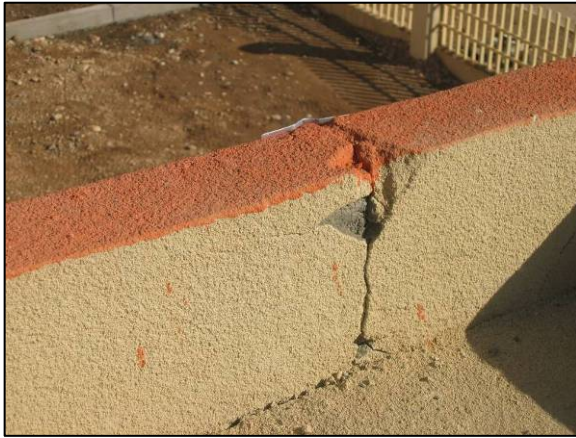
Expansion joints were installed to prevent stress cracks in the structural walls as the concrete expands and contracts during temperature changes. One expansion

joint on the roof was covered with concrete and experienced a stress crack about 8 cm long. SIGIR recommended that the parapet and the expansion joint be reconstructed. Site Photo 19 shows the stress crack along the roof. Site Photo 20 shows the corrective action taken subsequent to the site visit.

**Site Photo 19. Stress crack in concrete covering an expansion joint.**

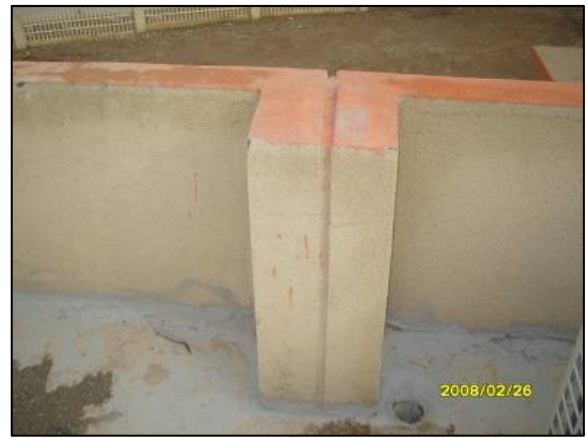
**Site Photo 20. Corrective action subsequent to site visit to reconstruct parapet and expansion joint.  
(Photo courtesy of MND-NE).**

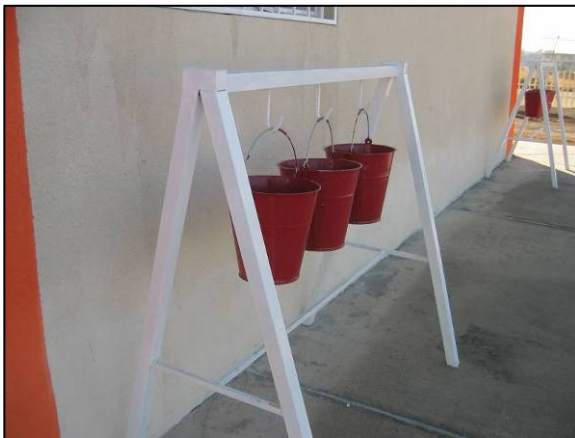
There were no fire sensors, alarms, or extinguishers in the building and we could find no requirement in the contract for these systems. The only fire safety equipment on site were bucket racks at the rear of the building shown in Site Photo 21. Site Photo 22 shows corrective action subsequent to the site visit.

**Site Photo 21. Fire bucket racks, the only fire safety equipment observed at the time of the site visit.**

- Adequate fire-sensing, alarm, and fire-fighting systems are installed.
  - The septic tank and cesspool area are secured to prevent access by students.

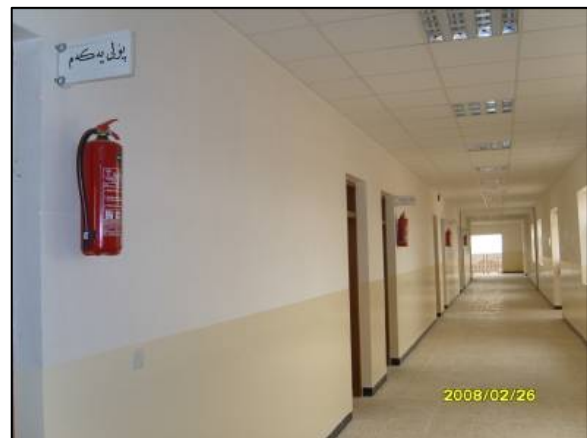
**Site Photo 22. Corrective action subsequent to site visit to provide interior fire fighting equipment  
(Photo courtesy of MND-NE).**

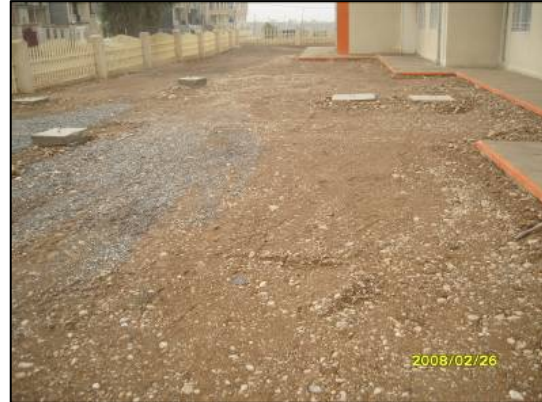
**Site Photo 24. Corrective action subsequent to site visit to properly grade the area.  
(Photo courtesy of MND-NE).**

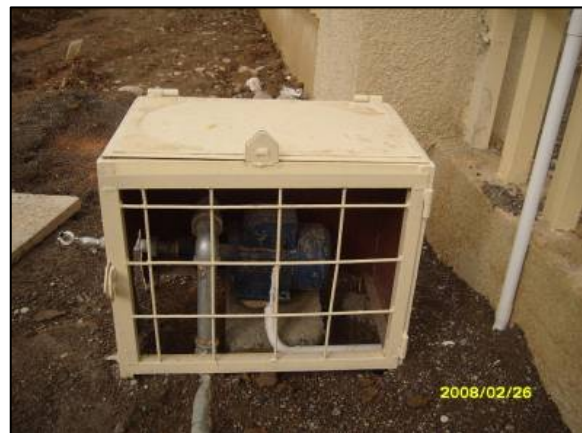
**Site Photo 26. Corrective action subsequent to site visit to provide a cover for the pump.  
(Photo courtesy of MND-NE).**

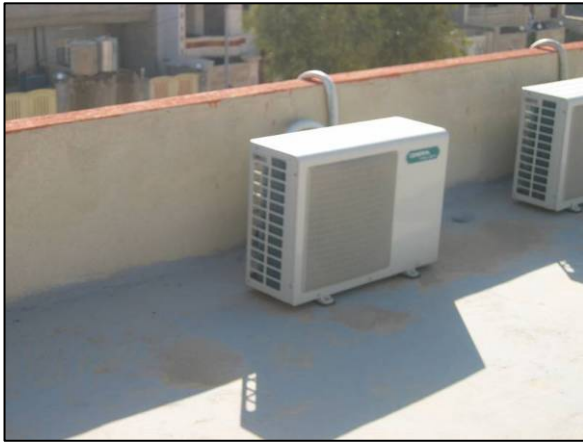
The split heating/air conditioning units on the roof were not yet anchored to the roof. Site Photo 27 shows unanchored heating/air conditioning units on the roof. Site Photo 28 shows the corrective action subsequent to the SIGIR site visit to anchor the heating/air conditioning units to the roof.

Site Photo 27. Split heating/air conditioning units not anchored.

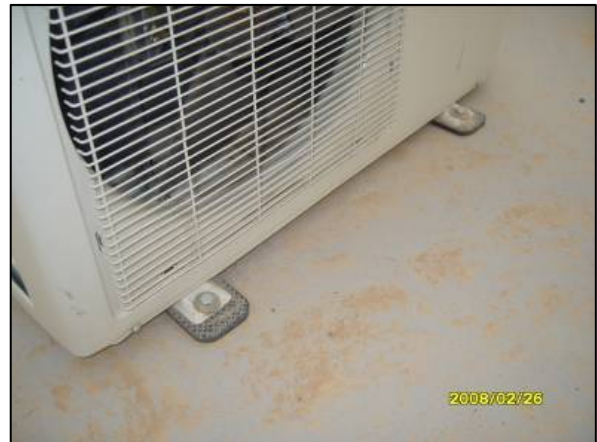
Site Photo 28. Corrective action subsequent to site visit to anchor air conditioning unit .  
(Photo courtesy of MND-NE).
